# CASE STUDY: DURABILITY OF STONE FLOORING IN HIGH TRAFFIC AREAS

**Prepared By The University of Tennessee Center for Clean Products.**

JAN 21 2009

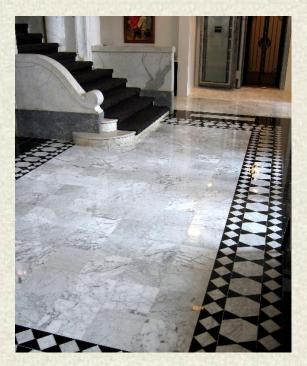
Black and white marble flooring was custom-cut during 2006 renovations of this 1914 building to mimic the appearance of the original bank. Located in a main corridor, this flooring continues to uphold its beauty and integrity despite the daily traffic.

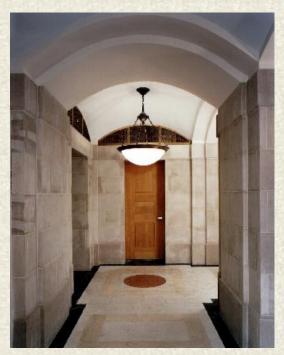
The Northwest Corridor design at Boston Public Library serves as a bridge between the historic architecture of Charles Follen McKim and a 1972 addition by Philip Johnson. Several varieties of marble were employed for the flooring in this area of the library.
